HISTORIC AMERICAN BUILDINGS SURVEY

HABS No. MO-1244

MOSES GASKILL HOUSE
(Tract #11219)

Prepared by William Brookover
Project Supervisor
Historic American
Buildings Survey
Summer 1977

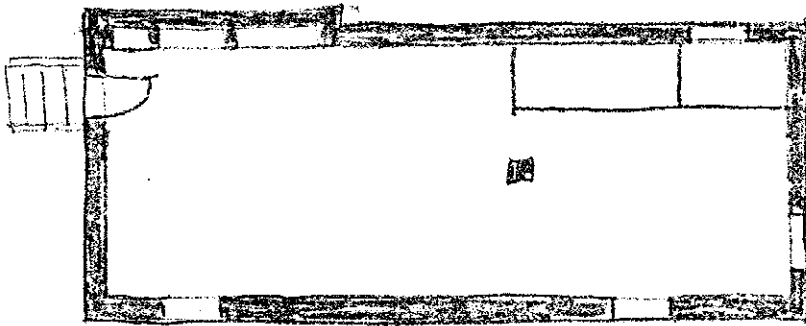
BASEMENT PLAN GASKILL HOUSE
#11219

1. Floor plan:
 - a. Basement: The stone-lined basement is entered by stairs at the east end of the house. Three niches in stone are located just inside the door in the southeast corner of the basement, and there are wooden storage bins in the southeast corner. A plastered brick column in the center supports the chimney and flue above.
 - b. First floor: The first floor has four rooms arranged in a cross plan. Porches fill the four corners.
2. Stairways: There is an exterior stone stairway to the basement at the east end of the plan.
3. Flooring: Wood flooring, painted around the perimeters of the rooms.
